## **Incident Involving 30-Ah Li-ion Cell at NASA Glenn Research Center:**

# Incident Involving 30-Ah Li-ion Cell at NASA Glenn Research Center

William R. Bennett

# Incident Summary

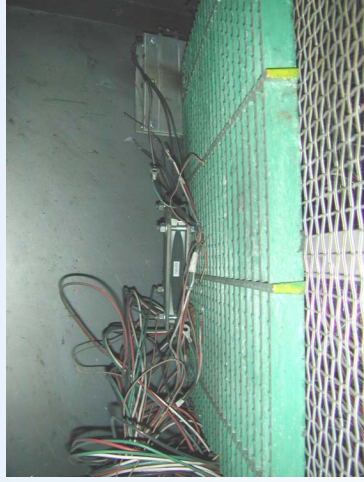
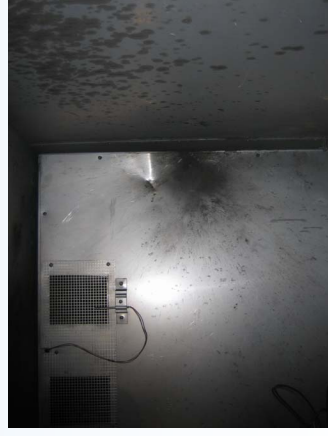
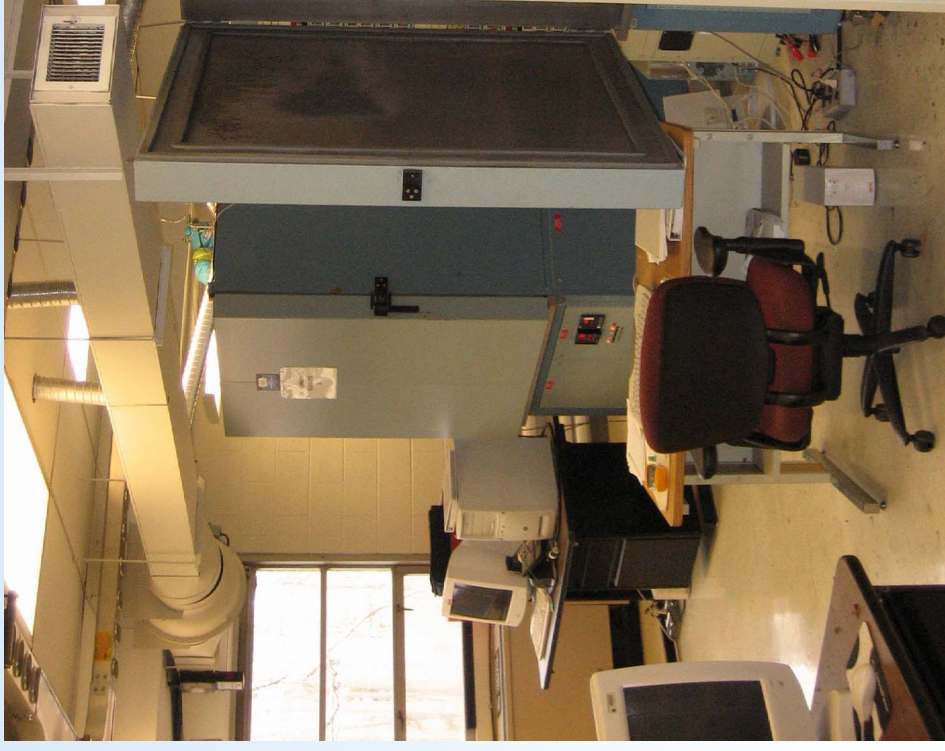
# Facility

Pressure build-up forced open door of 30 cu. ft. chamber.

Door knocked PC onto floor.

Cell ricocheted off chamber walls but remained inside chamber.

2. Facility rearrangement: Since the incident, chambers have been arranged to open towards the back of the room. Test consoles and Arbin hardware have been located out of the path of the chamber doors.

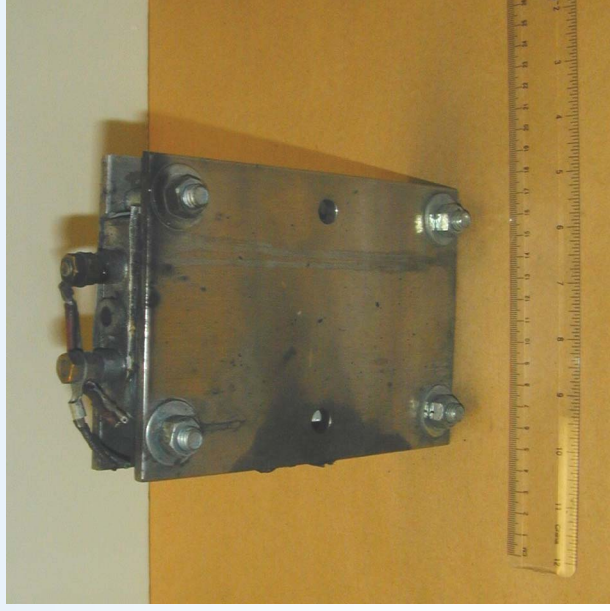
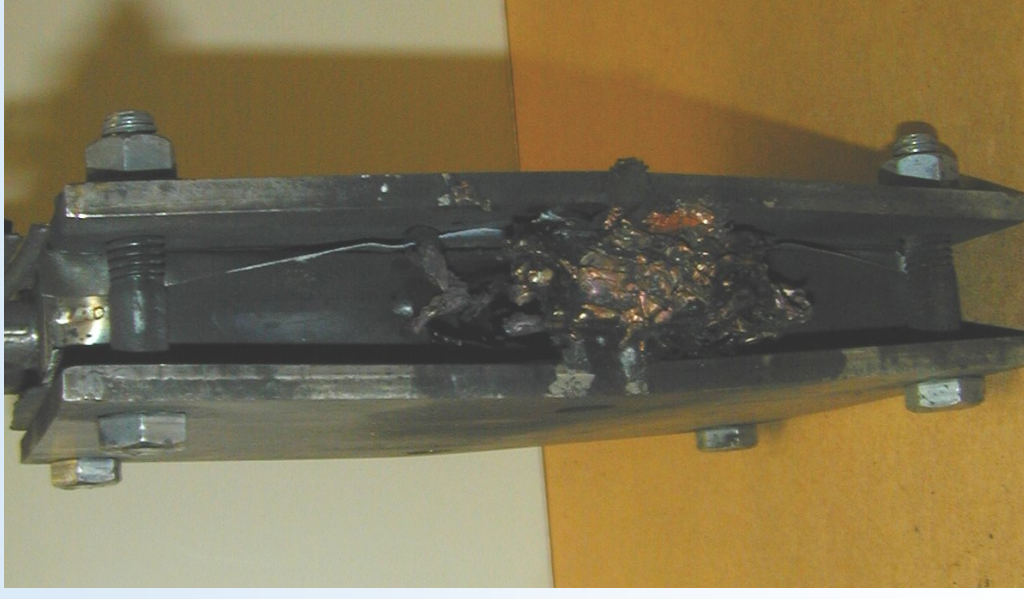
# Exploded Cell

Rupture disc vented.

End-plates in place but bent.

Case seam-weld ruptured.

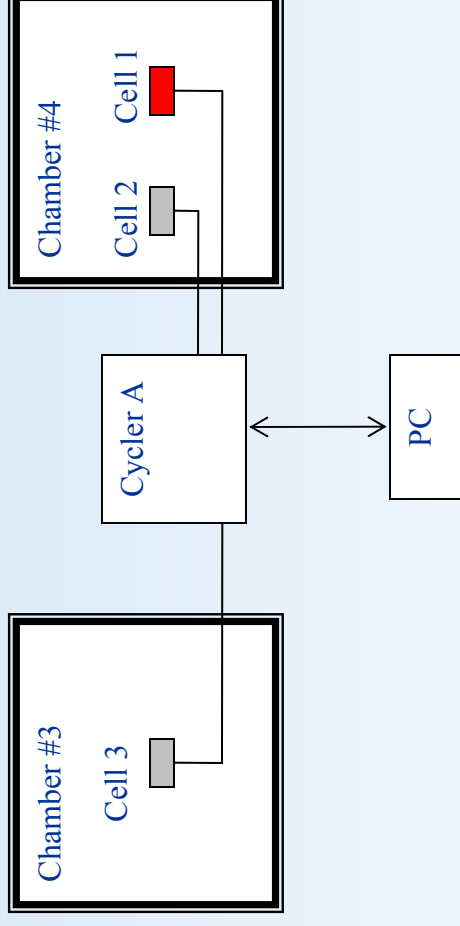
# Structure of Test Incident

- 3 cells under test.
- 2 separate chambers.
- One PC/cyclotron controlling all three tests.
- Cell 1 vented explosively.
- Cell 2 was not damaged.

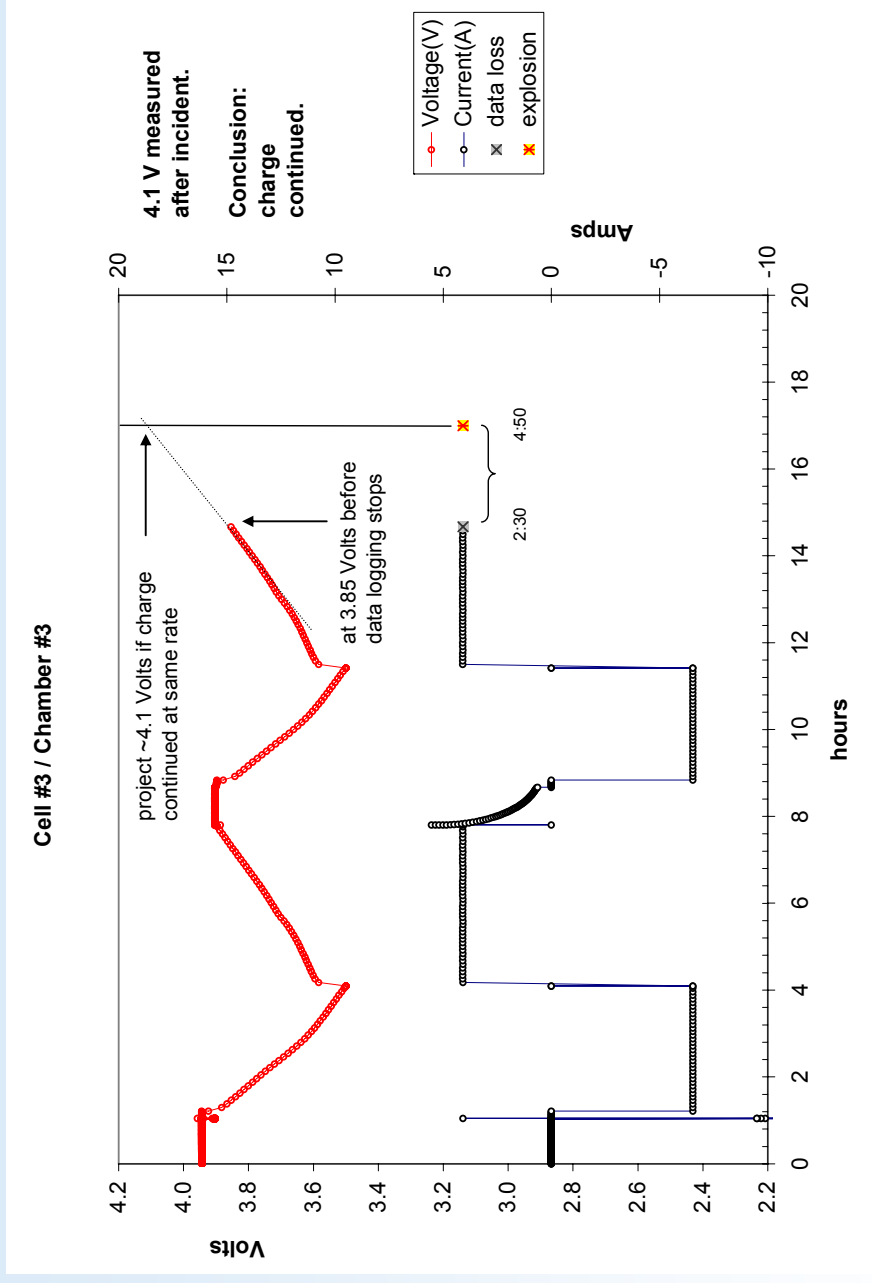
# Reconstruction of Data Cell #3

Cell is at 3.85 V and charging at 4 A at last logged data-point.

If charge continued, cell would be at 4.1 V at the time of the incident.

Matches OCV of 4.1 V measured after incident.

The 3.9 V upper cutoff was ignored.

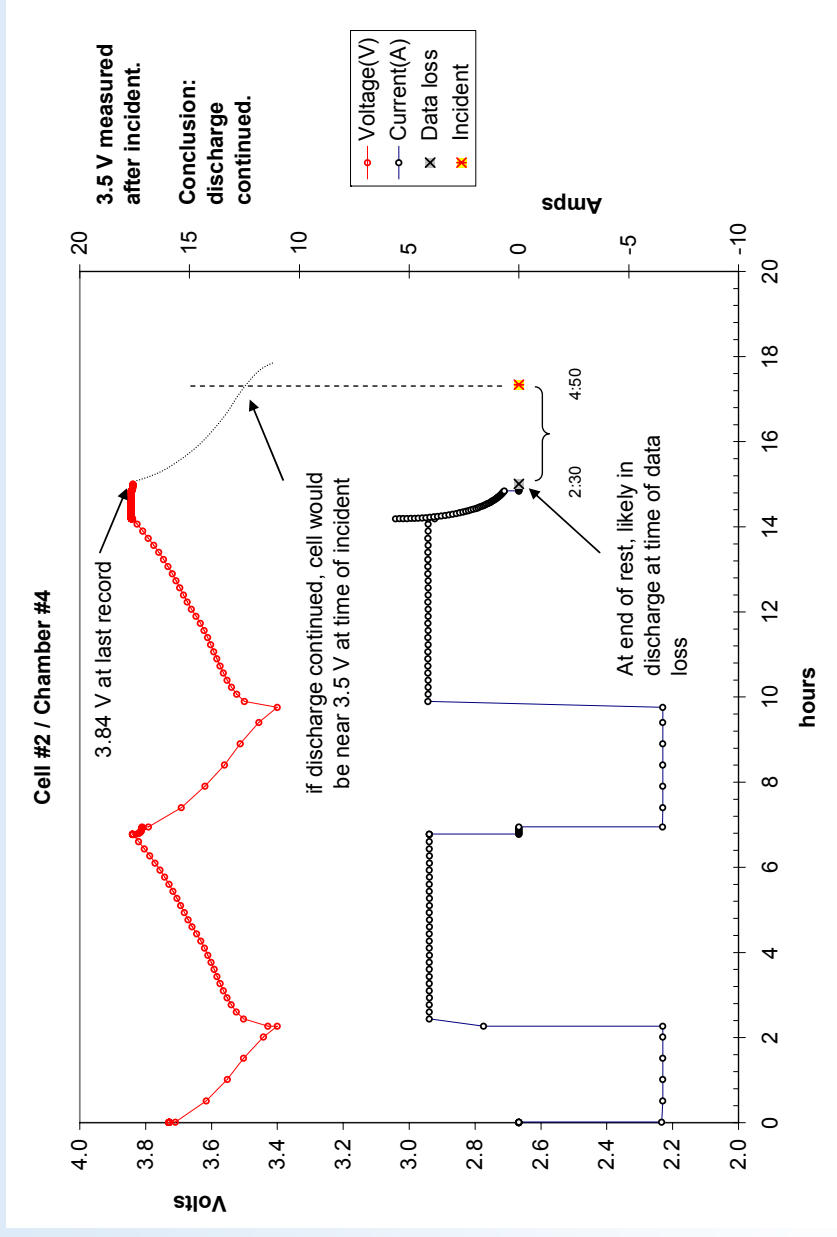
# Reconstruction of Data Cell #2

Cell is at 3.84 V, at end of rest at last logged data-point.

Likely to be in discharge at 6.5 A.

If discharge continued, cell would be at 3.5 V at the time of incident.

Matches OCV of 3.5 V measured after incident.

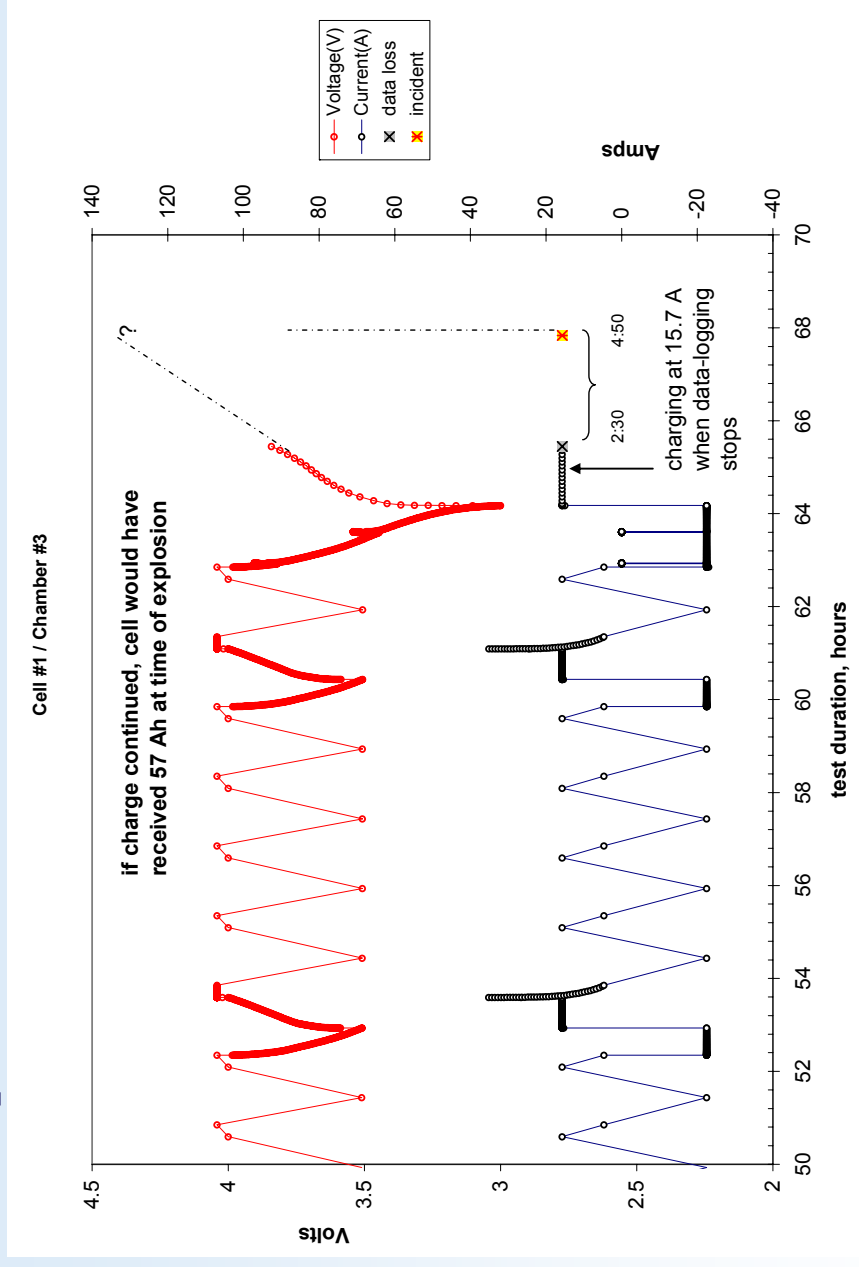
# Reconstruction of Data for Exploded Cell

If charge continued at same rate as last data point, cell would have absorbed 57 Ah at the time of the incident.

Nearly two-times the nominal capacity!

Severe overcharge of exploded cell.
